LESSONS FROM THE FIELD - EJECTOR SYSTEMS

James R. Lines, Graham Corporation, USA, presents the problems associated with ejector system performance and subsequent solutions.

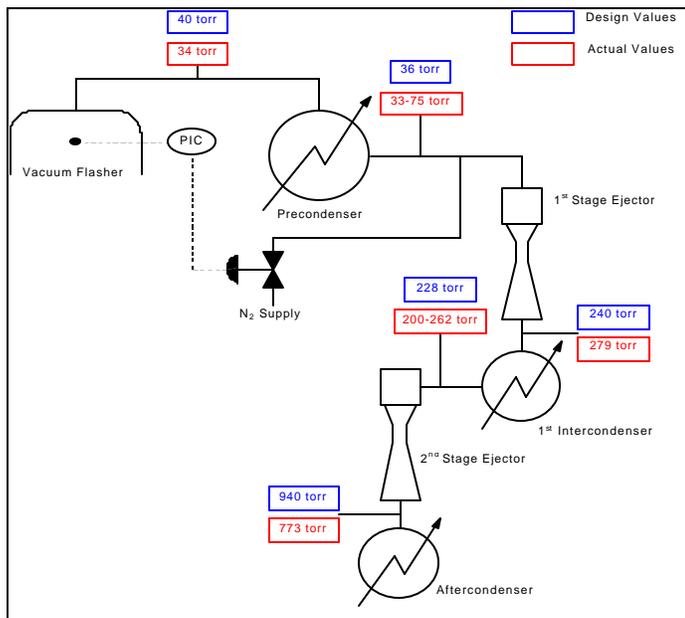
Figure 3. Survey 1 pressure profile

The precondenser produced adequate vacuum, but the two stage ejector system that extracted non-condensibles from the precondenser was performing in an unstable manner. Suction pressure of the first stage ejector was cycling between the design 35 torr and up to as high as 75 - 80 torr.

While inspecting the ejector system, the service engineer noticed a periodic audible change in ejector operation. This audible change plus an unstable suction and discharge pressure first stage ejector confirmed that this particular ejector was the trouble

The service engineer noticed plant personnel had installed a pneumatically controlled control valve that bled nitrogen to the suction of the first stage ejector. Plant personnel installed a nitrogen bleed as a means of controlling suction pressure to allow the vacuum flasher to operate at a consistent pressure even at reduced charge rates. Pressure in the top of the vacuum flasher was sensed and a signal sent to the control valve to bleed nitrogen to the first stage ejector if the

vacuum flasher pressure fell below design. Bleeding nitrogen, which is non-condensable, to the suction of a multi-stage condensing ejector system will result in unstable performance.

Once the first stage ejector began to handle more non-condensable loading than it was designed for, the down-stream ejector could not handle that increased non-condensables, plus the proportionate increase in vapors of saturation, at the achievable discharge pressure of the first stage ejector. This discontinuity in the achievable discharge pressure of the first stage ejector and suction pressure maintained by the second stage ejector based on higher non-condensable loading resulted in the first stage ejector breaking operation.

The service engineer instructed plant personnel to dis-assemble the nitrogen bleed arrangement and to install recycle control piping around the first stage ejector. For any multi-stage condensing ejector system, the preferred way to maintain performance and suction pressure is to recycle discharge from an ejector immediately preceding the first intercondenser back to the suction of the system. In this way, non-condensable loading is never allowed to increase above design, thus ensuring broken ejector operation will not occur. Again, vacuum flasher pressure is sensed and a signal sent to the recycle control valve, which will modulate and permit the recycle of vapor flow back to the suction of the first stage ejector. Once the plant installed this form of recycle control, stable ejector operation was maintained.

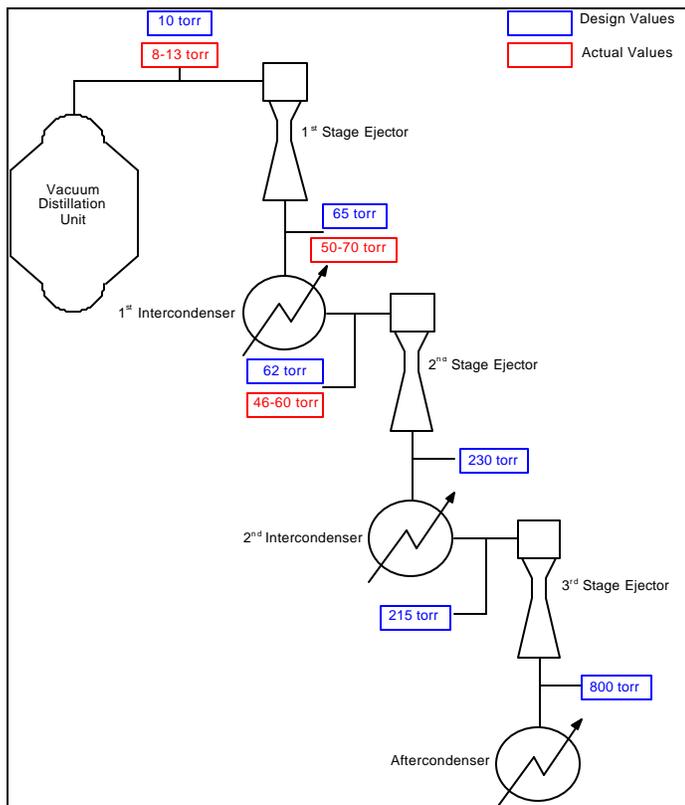
Figure 4. Survey 2 pressure profile

A West Coast refiner was operating a fuels vacuum distillation unit that experienced erratic performance after replacing an intercondenser supplied by the original ejector system manufacturer with one designed and built by a local heat exchanger fabrication shop. The as sold system was designed to provide performance described in Figure 4. The service engineer had no prior knowledge that the user installed a replacement intercondenser.

The first stage ejector was operating in a broken mode, with both suction and discharge pressure remaining unstable. Furthermore, shellside pressure drop across the first intercondenser was almost three times the design pressure drop.

Upon visual inspection of the installed unit and its name-plate, the service engineer realized it was the design of another vendor. That vendor did match the original intercondenser's tube count and external dimensions, but after a thorough review of fabrication drawings, it was evident the vendor failed to design the shellside baffling properly to manage hydraulic and thermal requirements. Vacuum condensers have special shell side baffling to ensure minimal pressure drop, non-condensable gas cooling, and separation of non-condensibles and condensate. It is typical to have different baffle spacing at strategic locations within the shell of a vacuum condenser or to incorporate a long air baffle design. The vendor who replaced the intercondenser used conventional software to model the performance. This in turn

resulted in a design having fully baffled flow, and consequently, excessive pressure drop on the vapor side.

In this particular instance, high pressure drop across the shellside caused the system to break performance. The first stage ejector could not overcome the added pressure drop and reach a discharge pressure where the second stage ejector would operate. This discontinuity resulted in the first stage ejector breaking operation, which was characterized by unsteady suction pressure and back-streaming of motive steam into the vacuum distillation tower. Both performance conditions were unsatisfactory to the refiner.

Although the plant engineers were reluctant to accept that the condenser was the problem, they did agree to install a new condenser designed by the ejector system manufacturer. Once the properly designed condenser was installed and the system restarted, performance returned to a satisfactory level.

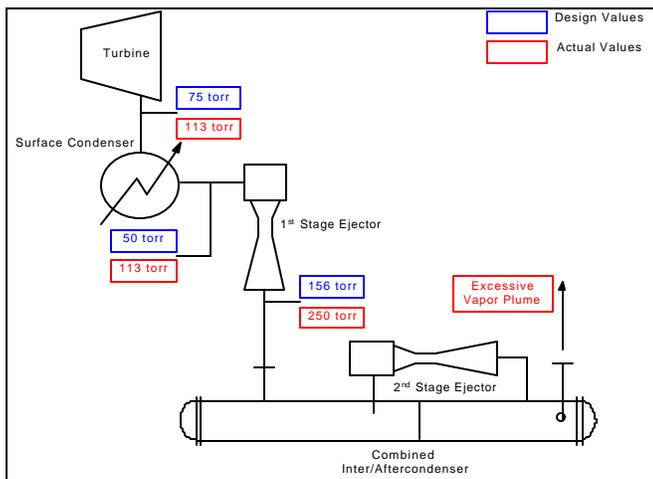
Figure 5. Survey 3 pressure profile.

An ammonia plant syngas compressor provided less than design horsepower due to high back pressure from a condensing turbine steam surface condenser. The turbine exhaust condenser maintained 113 torr back pressure, but based on the cooling water temperature, the expected back pressure should have been 75 torr. A service engineer was dispatched to the site to evaluate the steam surface condenser and exhauster performance to determine the cause of the elevated back pressure.

The steam surface condenser was supported by a two stage ejector system condenser exhauster (Figure 5). The service engineer noticed a substantial exhaust plume from the aftercondenser vent.

Normally, steam surface condenser and exhauster systems are vacuum tight, with air leakage less than Heat Exchange Institute design values, with typical air leakage of 5 lbs/hr or less. An excessive exhaust plume from an aftercondenser does suggest high air leakage. There was an air leakage meter installed on the vacuum system, and when activated, the measurement was off the scale.

The condenser was isolated from the vacuum system and pressure stayed fairly constant. This confirmed the air leakage was downstream of the condenser and that it was in the exhauster system. A closer look at the installation determined that a 1/4 in. instrument connection was left open and was not plugged. Evidently, a pressure gauge was damaged and plant personnel removed it but failed to replace it. The open connection permitted substantial quantities of air to leak into the ejector system and cause poor operation. The condenser was then brought on line once the connection was plugged and after the system was allowed to stabilize, steam surface condenser operating pressure reached 80 torr, which was in the range of what was expected. The syngas compressor returned to full power once this correction was made.

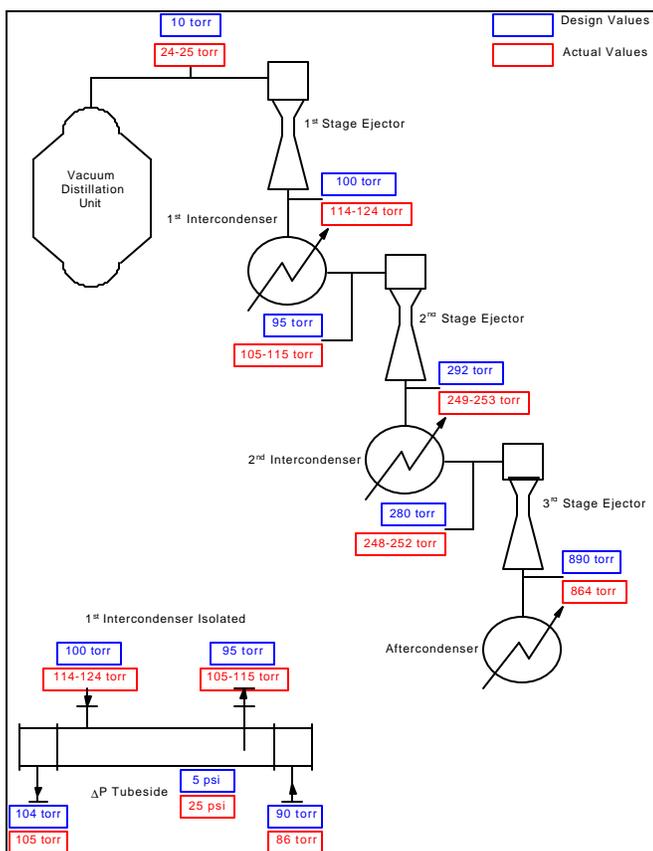
Figure 6. Pressure and temperature profile.

A Gulf Coast refiner was operating a damp crude vacuum distillation tower that was designed for 10 torr tower top pressure but was maintaining only 24 -25 torr. The first stage ejector was surging and back-streaming into the vacuum distillation unit. A factory service engineer was dispatched to the site to perform a system survey and evaluate causes of the poor performance.

Figure 6 documents as sold performance and what was measured in the field.

Design cooling water temperature rise across the first intercondenser was 14 °F (7.8 °C), however, the actual temperature rise was 19 °F (10.6 °C). Possible causes for an elevated temperature rise would be lower than designed cooling water flow or an increase in condensible load to the condenser. Pressure drop across the tubeside of the condenser gave an indication that something was wrong. The actual tubeside pressure drop was 25 psi (1.7 bar) while the design was only 5 psi (0.35 bar).

The tubeside of the condenser was fouled and the increased pressure drop across the condenser caused the recirculating pumps to circulate less water. Tubeside fouling to produce such an elevated pressure drop would be severe and actual tube blockage must have occurred.

Tubeside fouling deterred heat transfer and did not permit proper condensation of shell side vapors. This increased the pressure drop on the shell side of the condenser and elevated its operating pressure. By not permitting proper condensation of shellside vapors, the increased outlet flow of vapors caused an increase in pressure drop.

The first stage ejector could not overcome the elevated shell side pressure drop and, consequently, broke operation. The broken operation resulted in unstable suction pressure, surging and back-streaming of motive steam into the vacuum distillation unit. The first intercondenser was pulled from the platform and taken down to grade. At grade, the bundle was removed to inspect the shell side for fouling and to rod out the tubes. The shell side did not experience excessive fouling, but the tubeside had tubes blocked with solidified calcium carbonate and other inverse solubility salts.

Once the tubeside was cleaned and returned to acceptable condition, the bundle was reinstalled in the condenser, and the condenser taken up to the vacuum unit for re-hook up. When the system was brought in service, the tower top pressure was maintained at approximately 10 torr and system performance was stable.
