Maintenance and turnaround planning critical to successful ejector vacuum system operation

Steam ejector vacuum systems are generally considered to be reliable and require little maintenance. However, when preventive or corrective maintenance is required, ensuring it is done correctly is imperative. Failing to properly perform maintenance or turnaround work can result in a loss of performance or worse, a loss of production capacity. Many of the services that ejector systems operate in are critical services to the overall process.

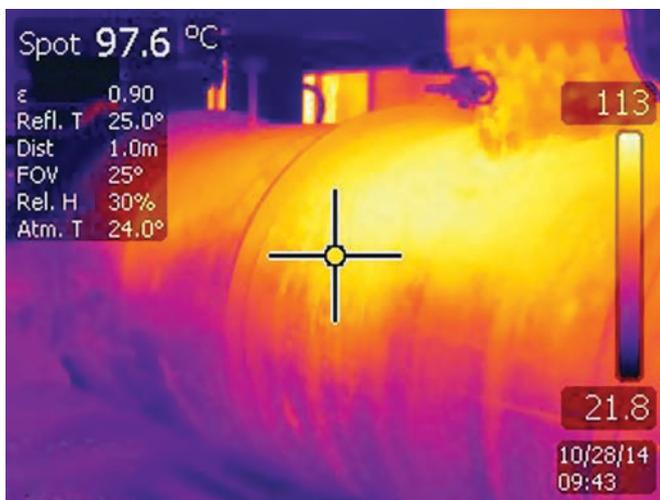
Discussion and onsite assistance identified that the condenser bundle sealing strips were not replaced during the turnaround. The condenser bundles had either been installed without sealing strips or the original sealing strips were severely damaged. Thermal images of the condensers (FIG. 2) were taken, and the temperature profile indicated bypassing through the sealing strips. This bypassing steam acts as a load to the downstream and, in this case, that bypass was severe enough that it was overloading the ejectors. This was directly responsible for the tower's poor performance.

FIG. 2. Thermal images of the condensers were taken and indicated bypassing through the sealing strips.

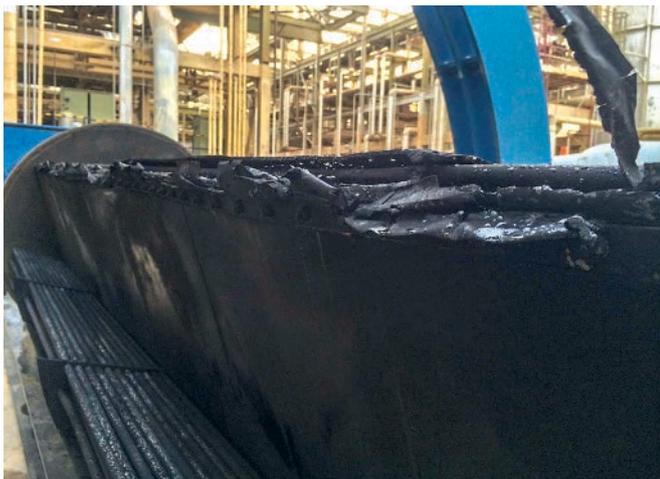
FIG. 3. Damaged sealing strips.

The refiner procured the required sealing strips and placed them into stock. Within 1 yr, an opportunity presented itself when the boiler that supplies steam to the ejector system had an unplanned outage. The refiner used this opportunity to pull the condenser bundles and confirmed that the sealing strips were either missing or in very poor condition (FIG. 3).

After the bundles were reinstalled with new sealing strips and the system was brought back online, the vacuum returned to the design of 15 mmHgA. To prevent this from reoccurring, this refiner has placed a hold point for engineering to inspect the cleaned bundles and verify new sealing strips have been installed prior to bundle reinstallation on all future condenser work.

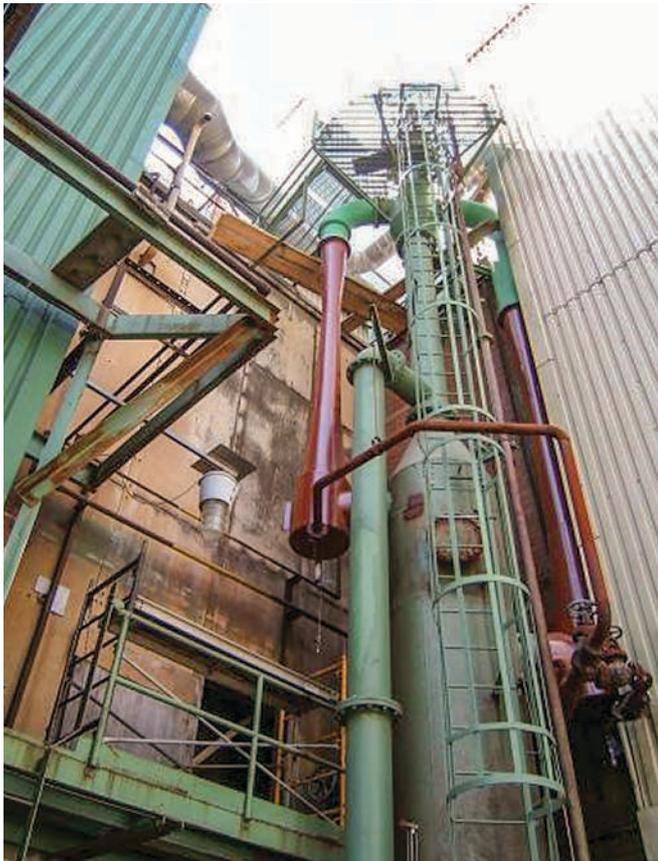
- The replacement diffusers were not concentric. As is often an issue with non-OEM diffusers, the replacement diffusers were oblong, which was negatively impacting performance.
 - The alignment was incorrect, meaning the new diffuser was not straight relative to the air chamber and motive nozzle. When the motive nozzle is incorrectly aligned with the diffuser, the motive steam will be focused towards one side of the ejector, reducing its efficiency.
- Replacement booster ejectors (FIG. 5) were ordered from

FIG. 5. OEM replacement ejectors on an SVRU.

the SVRU's OEM. Following installation, the performance of the system returned to design. Although ejectors appear simple from the outside, precision and alignment are critical. Small,

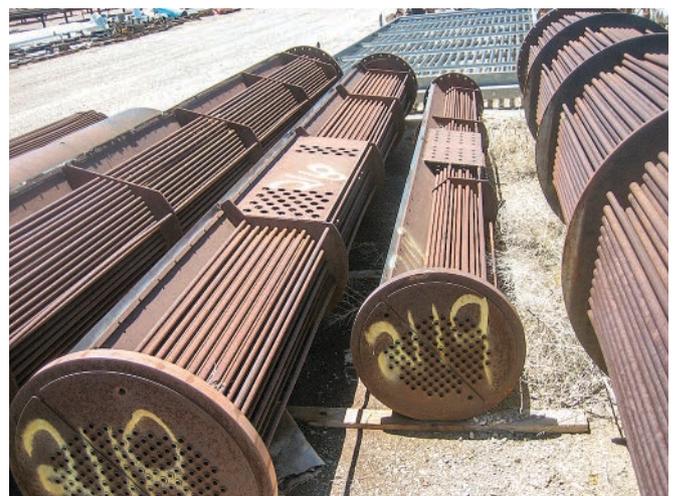
FIG. 6. A maintenance yard filled with failed bundles.

The original stainless-steel bundles lasted roughly 20 yr, whereas the replacement bundles lasted 18 mos. This short service life was due to the carbon steel oxidizing and developing a multitude of cooling water leaks. Another unfortunate side effect of selecting carbon steel is that rust buildup on the tubes impedes heat transfer and restricts cooling water flow, resulting in a reduction in performance. Although carbon steel works well at first, its performance quickly dissipates, resulting in tower instability and poor vacuum. As leaks develop, vast amounts of cooling water are also lost into the waste stream, increasing the load to the water treatment plant.

Due to the constant failure of the carbon-steel bundles, the refinery began replacing them every shutdown going forward. Before reaching out to the OEM for assistance, a total of 18 new carbon-steel condenser bundles were purchased from the heat exchanger vendor and installed, far exceeding the cost of stainless bundles. FIG. 6 shows failed bundles waiting to be scrapped. Replacing bundles has additional ancillary costs beyond the bundles themselves that include planning, shipping costs, cranes, additional manpower and lost production.
