LESSONS FROM THE FIELD - EJECTOR SYSTEMS

James R. Lines, Graham Corporation, USA, presents the problems associated with ejector system performance and subsequent solutions.

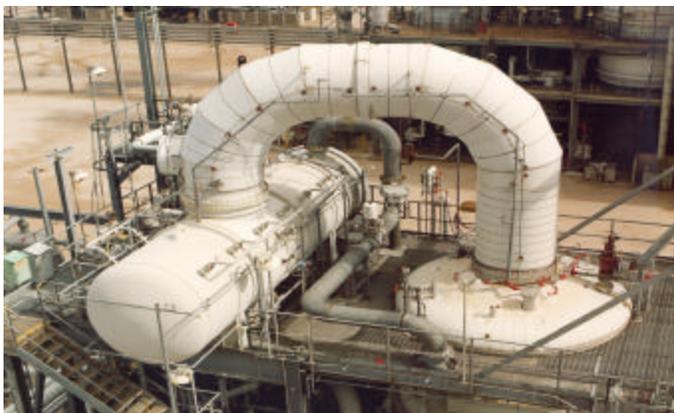
The precondenser produced adequate vacuum, but the two stage ejector system that extracted non-condensibles from the precondenser was performing in an unstable manner. Suction pressure of the first stage ejector was cycling between the design 35 torr and up to as high as 75 - 80 torr.

Figure 2. Precondenser to left of vacuum flasher

An ejector system experiencing unstable suction pressure is typically operating in a broken mode. Broken ejector performance is often caused by low motive steam pressure, which has already been ruled out, a fouled intercondenser, high cooling water temperature or water flow, both of which have been ruled out, non-condensable loading.

vacuum flasher pressure fell below design. Bleeding nitrogen, which is non-condensable, to the suction of a multi-stage condensing ejector system will result in unstable performance.

The service engineer instructed plant personnel to dis-assemble the nitrogen bleed arrangement and to install recycle control piping around the first stage ejector. For any multi-stage condensing ejector system, the preferred way to maintain performance and suction pressure is to recycle discharge from an ejector immediately preceding the first intercondenser back to the suction of the system. In this way, non-condensable loading is never allowed to increase above design, thus ensuring broken ejector operation will not occur. Again, vacuum flasher pressure is sensed and a signal sent to the recycle control valve, which will modulate and permit the recycle of vapor flow back to the suction of the first stage ejector. Once the plant installed this form of recycle control, stable ejector operation was maintained.
